Re: SSD 10272349 - Yiribana Logistics Estate

Environmental Representative: Monthly Report (ERM #4)

**SSD 10272349 - Yiribana Logistics Estate:
Environmental Representative Monthly Report (ERM # 4)
For the period 1 November 2024 to 30 November 2024**

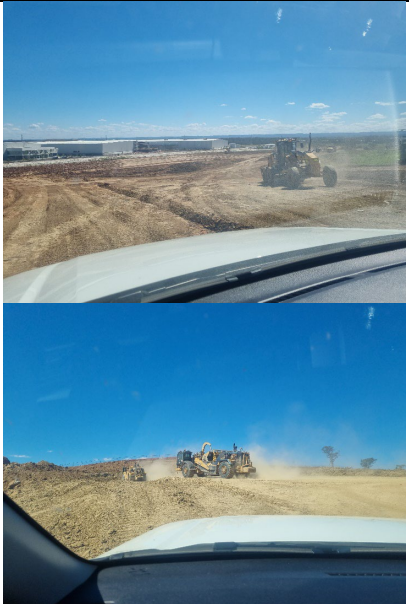
<p><u>08/11/24 – Dust Management Generally</u></p> <p>Lower lying areas are not raising much dust.</p> <p>This dust is not travelling very far when it is raised.</p> <p>Dust is being raised by scrappers running over the ramps to higher parts of the development.</p> <p>The access was being regularly wetted down</p>	<p>ONGOING DISCUSSIONS</p>

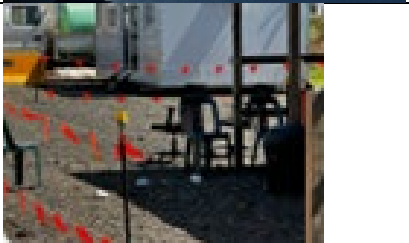
<p><u>Site Compound – 22/11/2024</u></p> <p>Some littering was observed in the site compound area.</p> <p>RISK - MEDIUM</p>	<p>OBSERVATION</p> <p>Recommendation</p> <p>Clean up existing litter and conduct toolbox talk with site personnel regarding the importance of good housekeeping</p>

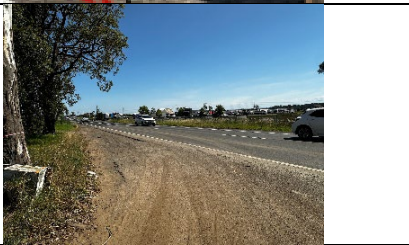
<p><u>Site Exit Point – 22/11/2024</u></p> <p>Rumble grid at the new site exit point is yet to be installed. Minor amounts of tracking observed with the potential for increased tracking due to vehicles driving over unsealed verges, accumulation of material at the site exit point.</p> <p>RISK - HIGH</p>	<p>OBSERVATION</p> <p>Recommendation</p> <p>Complete installation of the rumble grids. Regular inspection, maintenance and review of controls to ensure material is not tracked onto Mamre Road.</p>

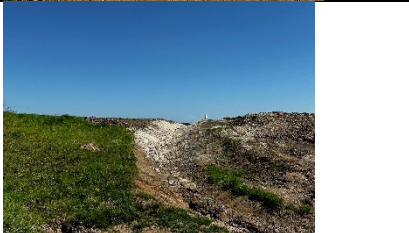
<p><u>Waterhouse 4 - Dirty Water Drain – 22/11/2024</u></p> <p>Check drains in dirty water drain are yet to be installed (as noted in B26 endorsement letter)</p> <p>RISK - MEDIUM</p>	<p>OBSERVATION</p> <p>Recommendation</p> <p>Install rock checks (or similar) as per the B26 letter of endorsement</p>
