**Re: SSD 10272349 - Yiribana Logistics Estate**

**Environmental Representative: Monthly Report (ERM #7)**

**SSD 10272349 - Yiribana Logistics Estate:**  
**Environmental Representative Monthly Report (ERM # 7)**  
**For the period 1 February 2025 to 28 February 2025.**

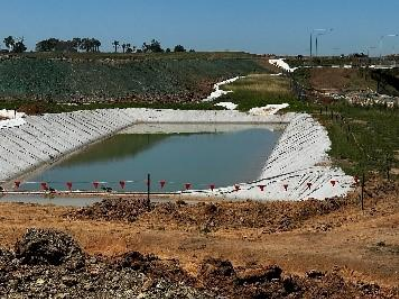
<p><u>Sediment Basins – 14/02/2025</u></p> <p>Sediment basins appear to be effective at capturing site runoff. Dewatering is planned prior to the Christmas shutdown to ensure adequate capacity over the shutdown period.</p>	<p><b>OBSERVATION</b></p> <p><b>CLOSED</b> – Basins were dewatered prior to XMAS shutdown with no incidents occurring over the XMAS, New Year period.</p>

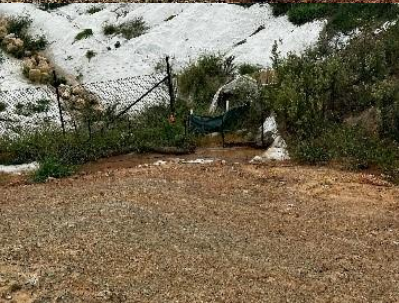
<p><u>Mirvac Boundary – 14/02/2025</u></p> <p>Sediment fence and coir logs at the Mirvac Boundary appear to be effective at capturing sediment.</p> <p><b>RECOMMENDATION</b></p> <p>Remove captured sediment so the ERSSED controls are operating at full capacity for the next rainfall event</p>	<p><b>OBSERVATION</b></p> <p><b>RISK LOW</b></p>

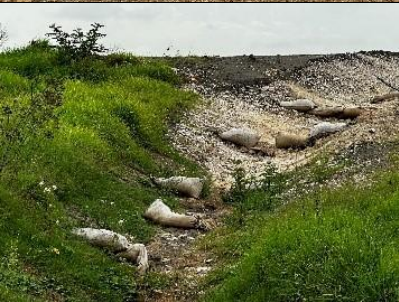
<p><u>Dirty Water Drain – WH4 Basin – 14/02/2024</u></p> <p>Sandbags within the dirty water drain leading to WH4 have become displaced and need reinstating</p> <p><b>RECOMMENDATION</b></p> <p>Reinstate sandbags so they are operating effectively</p>	<p><b>OBSERVATION</b></p> <p><b>RISK LOW</b></p>

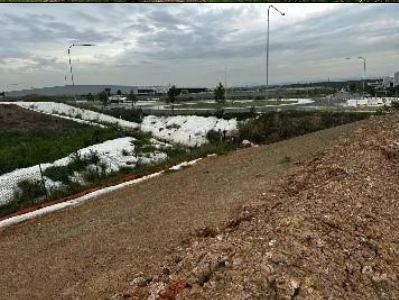
<p><u>Site Boundary adjacent to Mirvac Site – 14/02/2024</u></p> <p>Batter adjacent to the Mirvac site remains stable following storm event with no riling or des-stabilisation of the batter observed.</p>	<p><b>OBSERVATION</b></p>

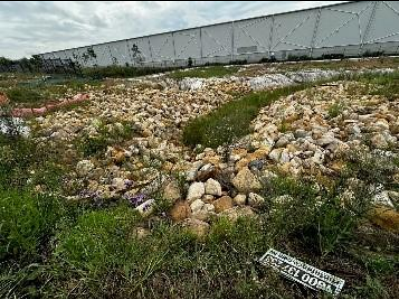
<p><u>WH2 Discharge Point – 14/02/2025</u></p> <p>The WH2 discharge point was inspected with no observed signs of scour following the overtopping event.</p>	<p><b>OBSERVATION</b></p>

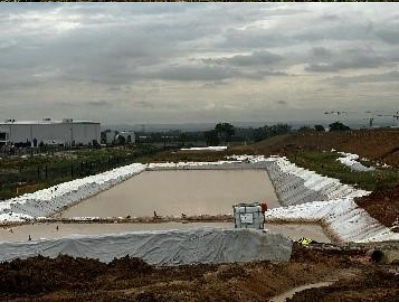
<p><u>Sediment Basins (generally) – 14/02/2025</u></p> <p>Sediment basins were generally full. Flocculation systems were in place to treat the water to acceptable levels.</p>	<p><b>OBSERVATION</b></p>

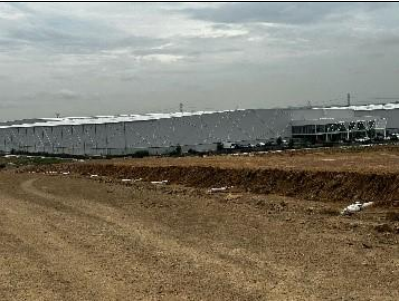
<p><u>Internal Haul Roads – 14/02/2025</u></p> <p>Sandbag checks were placed in drainage lines to reduce risk of scour. Controls appeared to be operating effectively.</p>	<p><b>OBSERVATION</b></p>

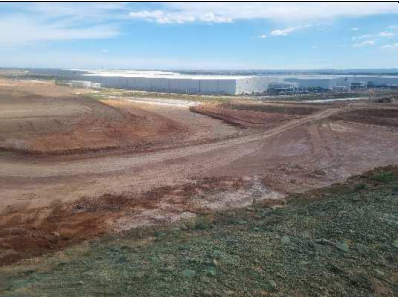
<p><u>Central swale / Riparian – 28/02/2025</u></p> <p>ESC planning in this area was discussed. The strategy is to be revised as the planned works at the 50/50 road necessitates the removal of the WH2 basin.</p>	<p><b>OBSERVATION</b></p>

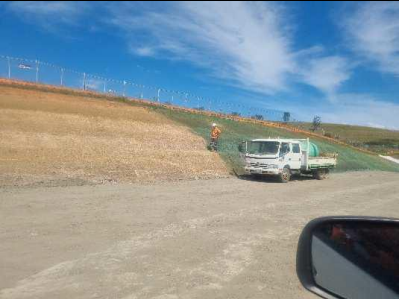
<p><u>Cut batter and retaining wall above WH1 – 28/02/2025</u></p> <p>The cut batter is being sprayed with polymer; A drop down chute is provided to receive water from the eastern catchment.</p> <p>This water must be accommodated by the sediment controls for this lot.</p>	<p><b>OBSERVATION</b></p>

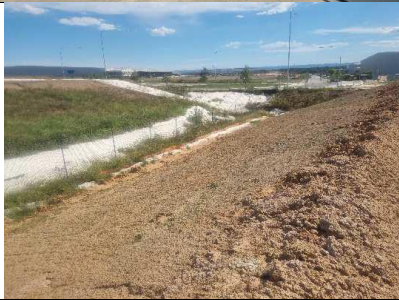
<p><u>Southern extent – batter to boundary – 28/02/2025</u></p> <p>The batter to the southern boundary is no longer stable.</p> <p>Sediment is accumulating within the lower sediment controls – these are full and need maintenance.</p> <p><b>The lower batters require re – treatment/stabilization and the lower controls maintained.</b></p>	<p><b>OBSERVATION</b></p> <p><b>RISK MEDIUM</b></p>

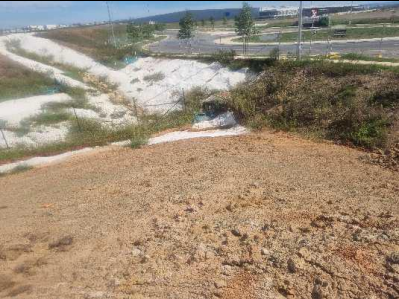
<p><u>Corner with AIE – 28/02/2025</u></p> <p>The control in this area requires attention. A larger control may be created on the GPT side which allows for water from the AIE site to drain to the pit from the southern side.</p> <p>The access to the 50/50 blocks drainage to the north.</p>	<p><b>OBSERVATION</b></p>

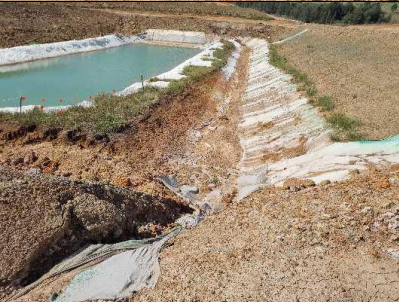
<p><u>WH1 and surrounds – 28/02/2025</u></p> <p>Batters around WH1 drain to the sides of the basin and the also the outlet channel.</p> <p>These areas cannot be made to report to the dosing point and inlet to the basin.</p> <p>Accordingly, these parts of the batters must be stabilised so run off may be considered clean.</p>	<p><b>OBSERVATION</b></p> <p><b>ONGOING</b></p>

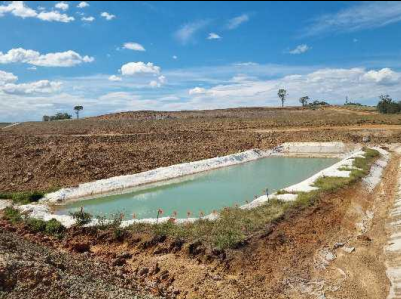
<p><u>WH1 and surrounds – 28/02/2025</u></p> <p>Scour is occurring in the NE corner of the basin. These flows do not pass to the dosing point.</p> <p>This portion of the catchment needs to be managed to the inlet and dosing point.</p>	<p><b>OBSERVATION</b></p> <p><b>ONGOING</b></p>

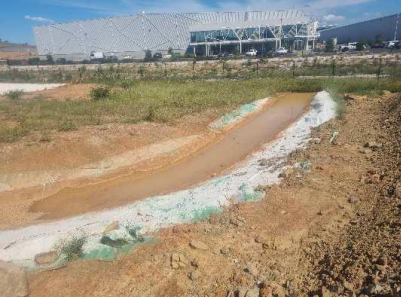
<p><u>Surrounds of the basin outlet WH3 – 28/02/2025</u></p> <p>The sounds of the outlet drain are not stable. This appears to be making sediment and clays accumulate within the outlet channel.</p> <p>The ESC should be improved / maintained in this area.</p>	<p><b>OBSERVATION</b></p> <p><b>ONGOING</b></p>
