**Re: SSD 10272349 - Yiribana Logistics Estate**

**Environmental Representative: Monthly Report (ERMR #10)**

**SSD 10272349 - Yiribana Logistics Estate:**  
**Environmental Representative Monthly Report (ERMR # 10)**  
**For the period 1 May 2025 to 31 May 2025.**

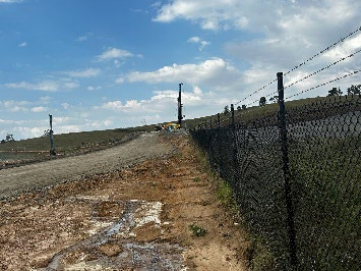
<p><u>Mirvac (Aspect Industrial Estate Boundary) – 14/04/2025</u></p> <p>The geofabric bund installed prior to the commencement of topsoil stripping adjacent to the Mirvac site appears to have been removed</p> <p><b>RECOMMENDATION</b></p> <p>Install new control to prevent water runoff to the adjacent site in consultation with the project CPESC. Action should be undertaken prior to Easter shutdown</p>	<p><b>RISK MEDIUM</b></p> <p><b>OBSERVATION ON 09/05/2025</b></p> <p>A new drain has been cut to divert water away from the site boundary. Refer to Item 5 below for details</p> <p><b>STATUS - CLOSED</b></p>

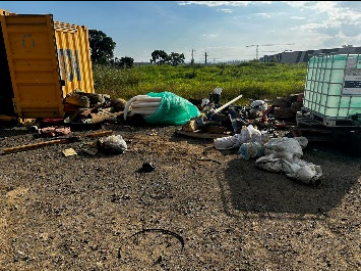
<p><u>Site Compound area – 14/04/2025</u></p> <p>Some litter was observed adjacent to the site compound</p> <p><b>RECOMMENDATION</b></p> <p>Clean up litter and remind all personnel of the requirement to place rubbish in the bins provided.</p> <p>Action should be undertaken prior to Easter shutdown.</p>	<p><b>RISK LOW</b></p> <p><b>OBSERVATION ON 09/05/2025</b></p> <p>Housekeeping in the carpark and compound area has improved with no litter observed.</p> <p><b>STATUS - CLOSED</b></p>

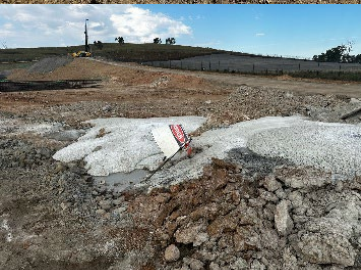
<p><u>Concrete Washout – 14/04/2025</u></p> <p>Concrete washout pit was being utilised; however, the advisory signage had fallen over.</p> <p><b>RECOMMENDATION</b></p> <p>Reinstate sign</p>	<p><b>RISK LOW</b></p> <p><b>OBSERVATION ON 09/05/2025</b></p> <p>As noted during the site inspection, with photographic evidence provided to the ER, the sign was reinstated. However, had recently been flattened by a truck. Regardless, the concrete washout was being utilised correctly as observed during the site inspection</p> <p><b>STATUS - OPEN</b></p>

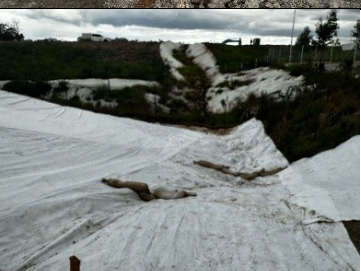
<p><u>Mirvac (Aspect Industrial Estate Boundary) – 09/05/2025</u></p> <p>Additional geofabric protection has been installed to protect batters and prevent scour. It was noted during the inspection the completed actions were in response to recent ER (CV) inspection</p>	<p><b>OBSERVATION</b></p>

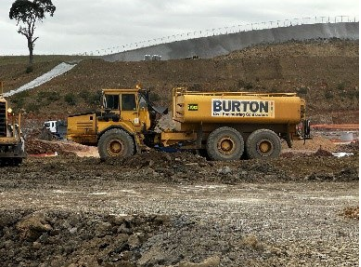
<p><u>General Site – 09/05/2025</u></p> <p>A water cart was operating across the site to prevent dust generation with none observed during the site inspection.</p>	<p><b>OBSERVATION</b></p>

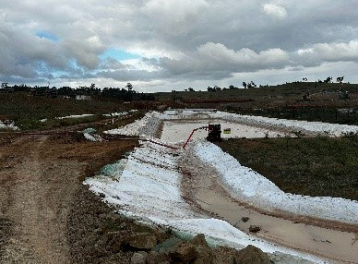
<p><u>Basin # 3 – 09/05/2025</u></p> <p>Rainwater has accumulated in the outlet chute (not from the HES Basin), with the potential to flow off site.</p> <p><b>RECOMMENDATION</b></p> <p>Pump the water back into the HES Basin and monitor the outlet chute to avoid the potential for an uncontrolled discharge.</p>	<p><b>OBSERVATION</b></p> <p><b>RISK - LOW</b></p>

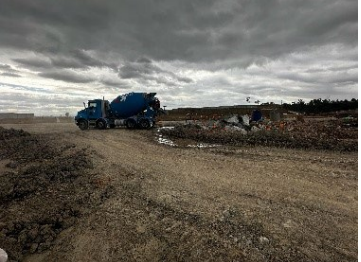
<p><u>Concrete Washout Pit – 09/05/2025</u></p> <p>Concrete washout pit was being utilised correctly (refer to item 3 regarding reinstatement/replacement of signage)</p>	<p><b>OBSERVATION</b></p>

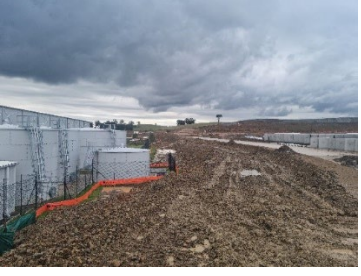
<p><u>Observations post rainfall – 23/05/2025</u></p> <p>Limited access available from southern gate way to 50/50.</p> <p>Discussions of the impacts and performance of controls post a heavy rain event were held at the southern entrance / gate.</p> <p>Water from the local catchments (including a portion of WH2 formation access and surrounds) has been detained within the 50/50 box out.</p> <p>This box out has flooded, and an overflow has occurred on the Western boundary leading to the fence with the Mirvac Estate.</p>	<p><b>OBSERVATION</b></p>

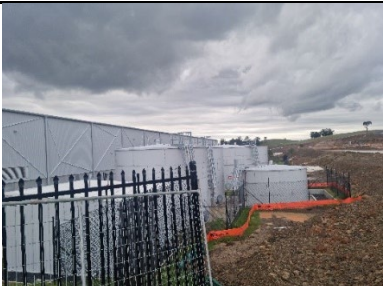
<p><u>Sediment movement at boundary – 23/05/2025</u></p> <p>Sediment laden water passed to the boundary to the west. Sediment fence in place and this has accommodated the volume from the eastern works. Sediment laden water passing through the basin has progressed to the concrete and drainage within the adjacent development. It does not appear that a large volume of water passed over the boundary The sediment fence at this location did not fail. <b>This area will be inspected when weather and ground conditions allow, and the flooded area has been dewatered.</b></p>	OBSERVATION

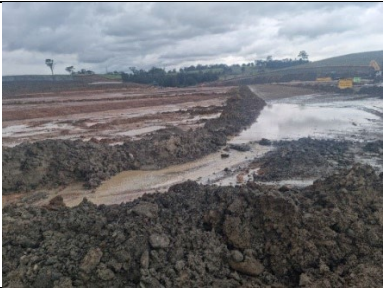
<p><u>Upper WH2 – 23/05/2025</u></p> <p>The upper catchment is shaped to drain to the perimeter swales and then into WH2 basin. Material from the western access has been pushed up the ramp to limit flows from this catchment reporting to the lower 50/50 box out.</p>	OBSERVATION

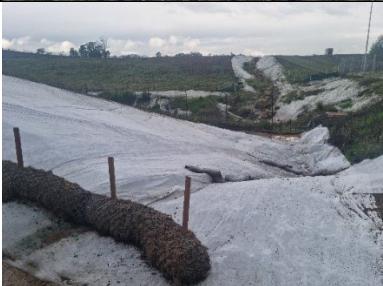
<p><u>SW corner – controls over batter – 23/05/2025</u></p> <p>Geotextile has been laid over the exposed batter at the SW corner of WH1. This fabric has accommodated the flows from the north. The surrounding batters have been treated with polymer to stabilise.</p>	OBSERVATION

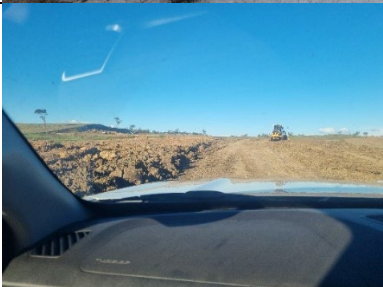
<p><u>Internal access roads and drainage – 30/05/2025</u></p> <p>The internal roads have been scraped clear of soft material. The scrapped material is to be moved to general fill areas. It was discussed that this work will act to retain water within the haul roads and direct water to other areas.</p>	OBSERVATION

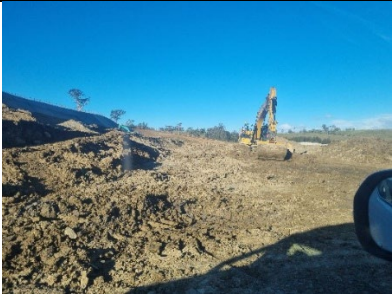
<p><u>Upper WH3 &amp; Drainage to new Basin WH3 – 30/05/2025</u></p> <p>The upper formation has been shaped to a new constructed HES within WH3.</p>	<p><b>OBSERVATION</b></p>

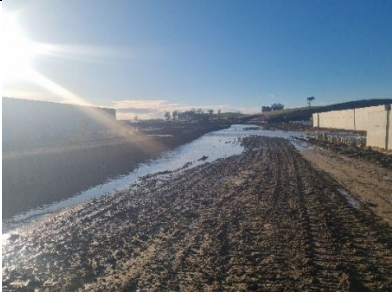
<p><u>Central clean water drain – 30/05/2025</u></p> <p>The central clean water drain is lined within the low flow. This drain passes through the site and bypasses any sediment controls.</p> <p>It was discussed that all formations/bunds and batters reporting to the central drain need to be covered to stabilise.</p> <p>It is recommended that an additional sump or sumps be provided to increase the capacity for storage outside the central drain. These storages will allow water to be managed away from the clean water drain and facilitate the pumping of water to construction basins for treatment.</p>	<p><b>OBSERVATION</b></p>

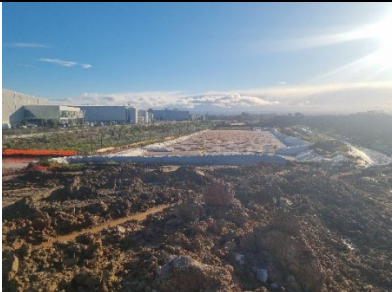
<p><u>Existing Basin WH3 – 30/05/2025</u></p> <p>The water within WH3 is turbid.</p> <p>It is noted that the previous rain event was of an intensity exceeding the design performance of the inlet and dosing controls for this basin. This basin has been treated and will be dewatered/cleared. This will be confirmed in subsequent inspections.</p>	<p><b>OBSERVATION</b></p>
