**Re: SSD 10272349 - Yiribana Logistics Estate**

**Environmental Representative: Monthly Report (ERMR #12)**

**SSD 10272349 - Yiribana Logistics Estate:**  
**Environmental Representative Monthly Report (ERMR # 12)**  
**For the period 1 July 2025 to 31 July 2025.**

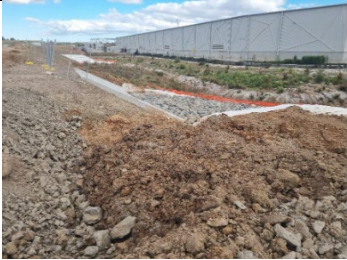
<p><u>Surrounds to culvert works – 23/07/2025</u></p> <p>The outlet from the main culvert has been completed.</p> <p>The catchments to the sides of the outlet and headwall are exposed and should be shaped and stabilised to remove any sediment hazard below the culvert headwall to the creek.</p> <p>It was also recommended that the exposed batters to the formation at the Western side should be progressed as a priority to remove the sediment risk to the riparian zone.</p>	<p><b>OBSERVATION</b></p> <p><b>RISK MEDIUM</b></p>
