**Re: SSD 10272349 - Yiribana Logistics Estate**

**Environmental Representative: Monthly Report (ERM #3)**

**SSD 10272349 - Yiribana Logistics Estate:  
Environmental Representative Monthly Report (ERMR # 3)  
For the period 1 October 2024 to 31 October 2024**

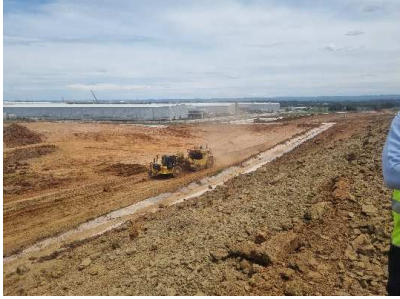
Dust Management Generally – 31/10/24

Dust management remain an ongoing focus of environmental management at the site especially once works areas progress in elevated portions of the site or where the landform no longer provides protection from wind.

Ongoing use of water cart and consideration of polymer application is required.

Daily monitoring a visual record of conditions and dust generation should also be undertaken
