Re: SSD 10272349 - Yiribana Logistics Estate

Environmental Representative: Monthly Report (ERMR #8)

SSD 10272349 - Yiribana Logistics Estate:
Environmental Representative Monthly Report (ERM # 8)
For the period 1 March 2025 to 31 March 2025.

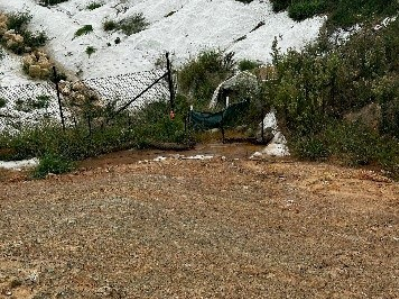
<p><u>Mirvac Boundary – 14/02/2025</u></p> <p>Sediment fence and coir logs at the Mirvac Boundary appear to be effective at capturing sediment.</p> <p>RECOMMENDATION</p> <p>Remove captured sediment so the ERSED controls are operating at full capacity for the next rainfall event</p> <p>RISK LOW</p>	<p>OBSERVATION on 14/03/2025</p> <p>Sediment has been removed with fresh controls including additional geofabric and coir logs secured with star pickets.</p> <p>Polymer spray has been applied to stabilise the soil above the controls.</p>

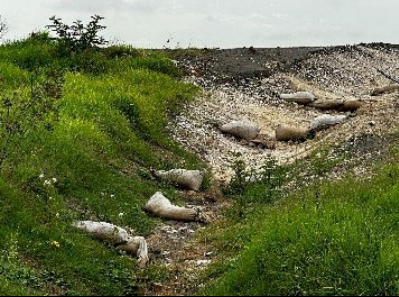
<p><u>Dirty Water Drain – WH4 Basin – 14/02/2024</u></p> <p>Sandbags within the dirty water drain leading to WH4 have become displaced and need reinstating</p> <p>RECOMMENDATION</p> <p>Reinstate sandbags so they are operating effectively</p> <p>RISK LOW</p>	<p>OBSERVATION on 14/03/2025</p> <p>Sandbags appear to have been repositioned, although the ER notes these controls should be checked prior to and following wet weather events.</p>

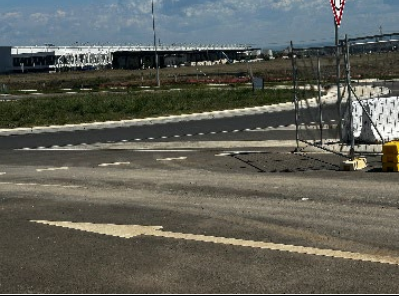
<p><u>Aspect Industrial Estate – Site Entrance – 13/03/2025</u></p> <p>Heavy vehicle transport routes have been redirected via the adjacent Aspect Industrial Estate. A street sweeper was in operation at the entry/ exit point. This means there are no heavy vehicles accessing the site via Mamre Road.</p>	<p>OBSERVATION</p>

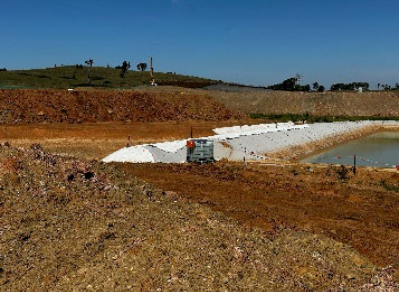
<p><u>General – Sediment Basins – 13/03/2025</u></p> <p>As noted in recent CPESC inspection, flocculation units have been replenished.</p>	<p>OBSERVATION</p>

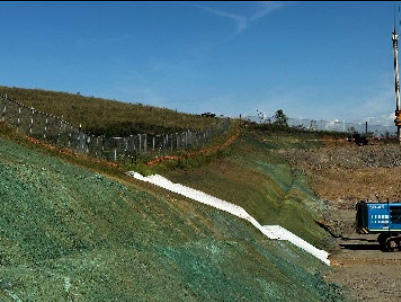
<p><u>General – 13/03/2025</u></p> <p>A significant stabilisation program has been initiated focussing on batters and high-risk areas.</p>	OBSERVATION

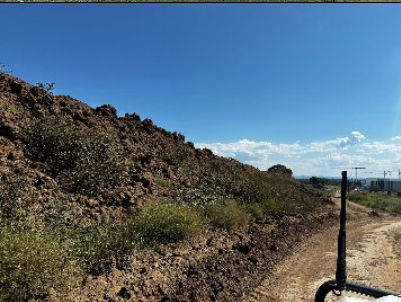
<p><u>General – 13/03/2025</u></p> <p>Evidence of weed control for sticky night shade was observed.</p>	OBSERVATION

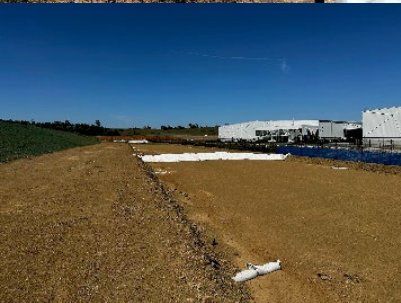
<p><u>General – 13/03/2025</u></p> <p>Additional sandbag controls installed upstream of sediment basins as recommended by CPESC.</p>	OBSERVATION

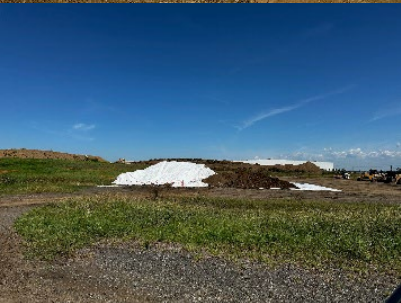
<p><u>General – 13/03/2025</u></p> <p>It was noted during the site inspection that some asbestos had been discovered on site with testing undertaken. Material had been temporarily stockpiled.</p>	OBSERVATION
			OBSERVATION
