**Re: SSD 10272349 - Yiribana Logistics Estate**

**Environmental Representative: Monthly Report (ERM #9)**

**SSD 10272349 - Yiribana Logistics Estate:**  
**Environmental Representative Monthly Report (ERM # 9)**  
**For the period 1 April 2025 to 30 April 2025.**

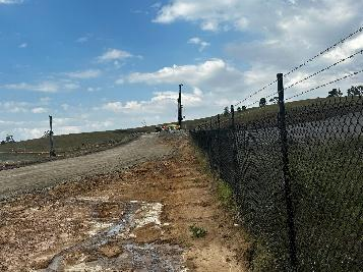
<p><u>Mirvac (Aspect Industrial Estate Boundary) – 14/04/2025</u></p> <p>The geofabric bund installed prior to the commencement of topsoil stripping adjacent to the Mirvac site appears to have been removed</p> <p><b>RECOMMENDATION</b></p> <p>Install new control to prevent water runoff to the adjacent site in consultation with the project CPESC. Action should be undertaken prior to Easter shutdown</p>	<p><b>OBSERVATION</b></p> <p><b>RISK MEDIUM</b></p>

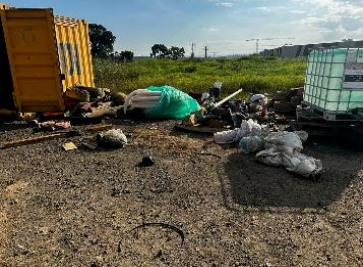
<p><u>Site Compound area – 14/04/2025</u></p> <p>Some litter was observed adjacent to the site compound</p> <p><b>RECOMMENDATION</b></p> <p>Clean up litter and remind all personnel of the requirement to place rubbish in the bins provided.</p> <p>Action should be undertaken prior to Easter shutdown.</p>	<p><b>OBSERVATION</b></p> <p><b>RISK LOW</b></p>

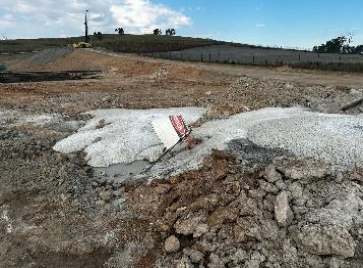
<p><u>Concrete Washout – 14/04/2025</u></p> <p>Concrete washout pit was being utilised; however, the advisory signage had fallen over.</p> <p><b>RECOMMENDATION</b></p> <p>Reinstate sign</p>	<p><b>OBSERVATION</b></p> <p><b>RISK LOW</b></p>

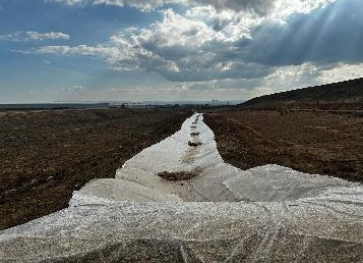
<p><u>General – 14/04/2025</u></p> <p>Clean water diversion has been installed through the site with rock check dissipators evenly spaced.</p>	<p><b>OBSERVATION</b></p>

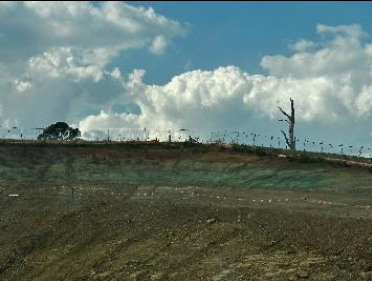
<p><u>General – 14/04/2025</u></p> <p>Stabilisation of completed batters – ongoing activity.</p>	<b>OBSERVATION</b>

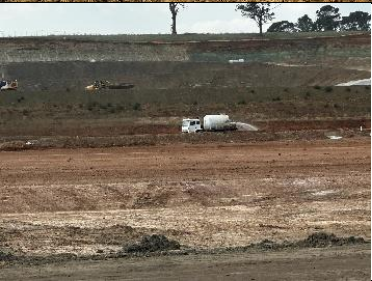
<p><u>General – 14/04/2025</u></p> <p>Water cart in operation to control dust</p>	<b>OBSERVATION</b>

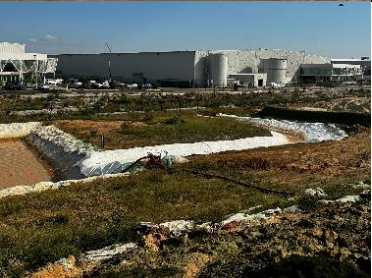
<p><u>Sediment Basin 3 – 14/04/2025</u></p> <p>Basin 3 outlet has been re-lined with geofabric.</p>	<b>OBSERVATION</b>

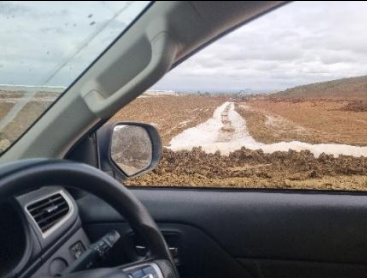
<p><u>Lined clean water channel – 30/04/2025</u></p> <p>The clean water diversion has now been lined and will not be formed to detain water.</p>	OBSERVATION

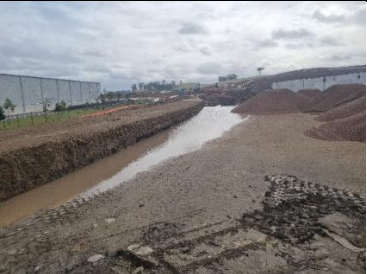
<p><u>50/50 road works and management of water – 30/04/2025</u></p> <p>Water is being detained in the box out and will be transferred to the adjacent on lot basin (WH2) for treatment.</p>	OBSERVATION

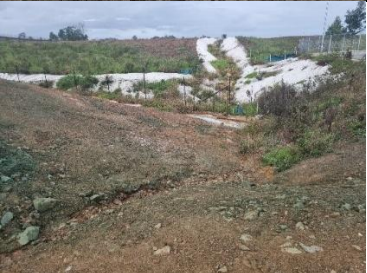
<p><u>Interface with MIRVAC Property – 30/04/2025</u></p> <p>Additional controls /maintenance is required in this area.</p> <p>Re application of polymer is required where the current treatment is breaking down.</p> <p>Sediment controls need to be cleared and reinstated where these have been degraded.</p>	OBSERVATION

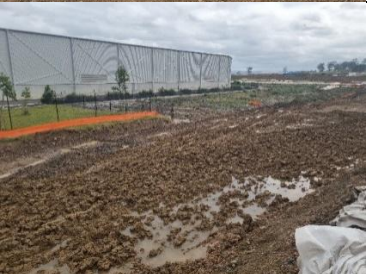
<p><u>Western extent and works at riparian – 30/04/2025</u></p> <p>Improvements are required in this area.</p> <p>A bund is required to prevent water draining directly to the Riparian zone. Detained waters may then be pumped back to the on-lot basin within WH2.</p> <p>Areas below the bund are to be stabilised.</p>	<p>OBSERVATION</p> <p>RISK MEDIUM</p>
